Vanities of the BONFIRE

By HENRY PETROSKI

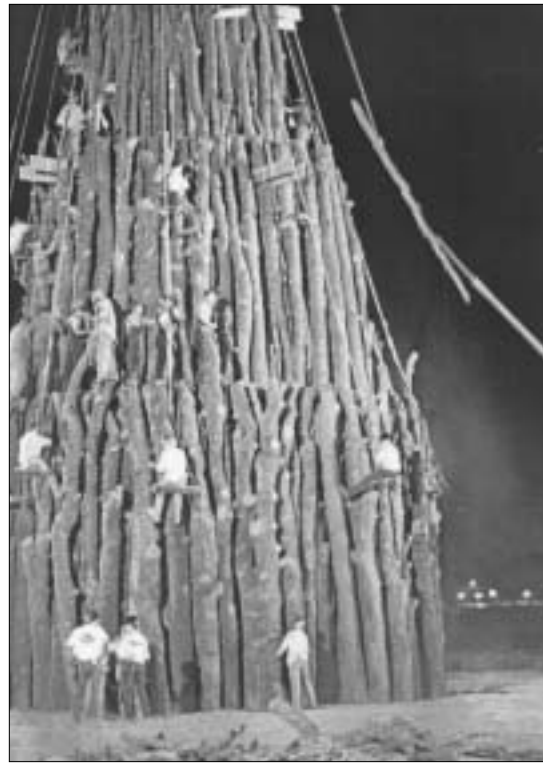
Bonfire is a 90-year-old tradition at Texas A&M University. The collapse in 1999 killed 12 students and injured many others.
