Ergonomics-based Methods of Inspecting, Assessing and Documenting Environmental Sites of Injurious Falls

**Jake L. Pauls, CPE
Jake Pauls Consulting Services
Silver Spring, MD**

**Stanley C. Harbuck, CAPS
School of Building Inspection
Salt Lake City, UT**

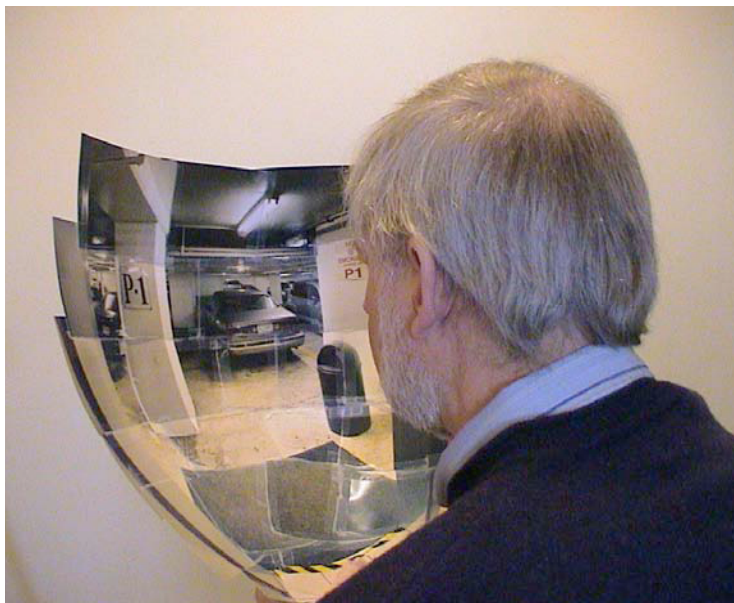
Exhibit 1: Correct viewing of normal-perspective photo panorama is depicted by Jake Pauls

Generally, “expectation” is a key factor in missteps and falls of many types and this must affect the nature of what is documented when investigating a site and other factors after a fall. A classic error made by many fall site investigators is indiscriminate use of auxiliary lighting and of wide-angle lenses when photographing a fall site. Unless the fall occurs in a mining situation where it is common for workers to have a light on the top of their head, it is unheard of for a typical pedestrian faller to have a light on his/her head immediately prior to experiencing a misstep and fall. Thus it is improper to utilize such an auxiliary light to illuminate a scene when trying to photograph a scene—as it was *supposedly* seen by the fall victim.

Similarly, the optics of human eyesight are not those of a wide-angle lens of a camera which tends to distort the relative size and placement of objects in the visual field. Thus, to reasonably document a fall site in a way that is representative of what a falling person would have seen immediately before a fall one must use photographic equipment wisely, including use of a reasonably normal perspective lens and a tripod to hold the camera steadily so that long exposures—allowing good depth of field—can be taken using available light only—*specifically light comparable to that present at the time of the fall*. Appropriate, time-tested techniques for doing this, and preparing the multi-image exhibits or “panoramas,” were described by Pauls.¹ The correct way of viewing such multi-image panoramas is depicted in Exhibit 1; this describes the site of an air step at a doorway to an underground parking garage where there was a hidden step down, shown with zebra marking added in the exhibit. Other protocols to observe generally in investigative photography have been addressed comprehensively by Wenzel.⁸

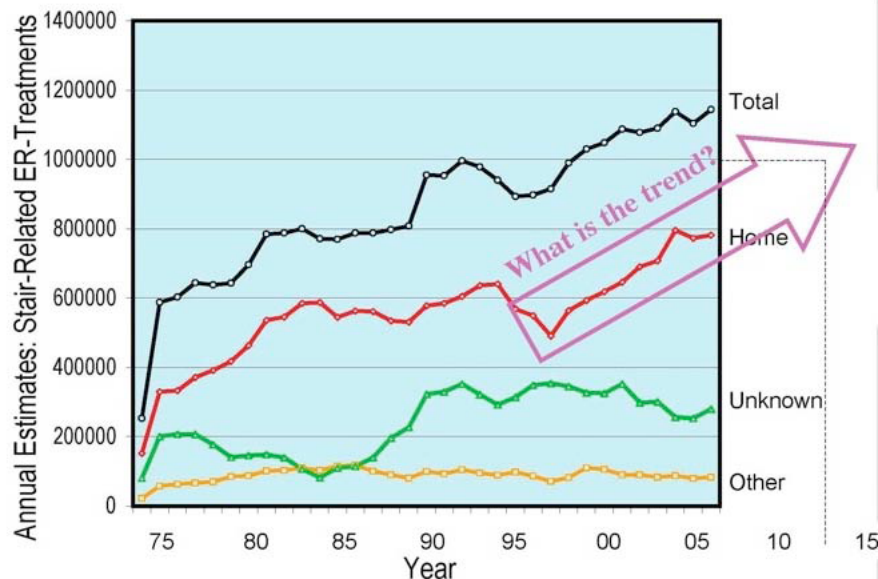
Exhibit 3: National estimates of stair-related injuries are based on US CPSC/NEISS data.

The authors believe that no other test performed in home and other building inspection, if diligently carried out, would have a similar fall and injury prevention impact as this one test would. As the defect appears to be most prevalent in homes, including perhaps a sizable fraction of all new homes constructed in recent decades, this might be a factor in the extraordinary growth in home-stair related injuries reported in the US Consumer Product Safety Commission (CPSC) National Electronic Injury Surveillance System (NEISS) national estimates especially in the last decade. Compared to an essentially flat trend for stairs not in homes, CPSC/NEISS national estimates for hospital emergency department-treated injuries reported for home stairs have a 4-percent annual growth rate with a 40 percent increase in the last ten years or so.⁹ Exhibit 3 depicts the trends.

are fires. In Exhibit 3, if fire-related injuries were plotted they would lie below the lowest, “other” curve and would show a 50 percent drop over a three-decade period, contrasting sharply with the 100 percent increase for all stair-related injuries during the same period. (See also Exhibit 4 regarding burden of injury for stair-related injuries.)

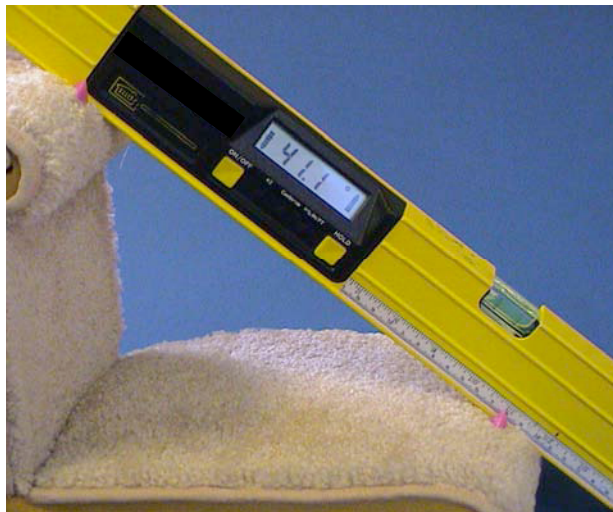
Exhibit 6: Electronic level method used with marker pins stuck through carpeted stair.

colleague and published in greater detail, including guidance on how the method could be utilized where the stair treads were carpeted.¹⁵ Exhibit 6 illustrates one method for using the technique with a carpeted stair where it is important to identify where a person's foot would be supported by solid structure below the carpet and possible padding.

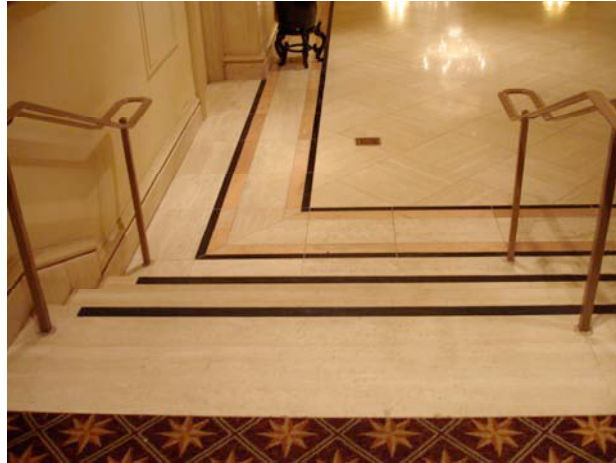
Exhibit 7: This hotel lobby stairway illustrates the dangers of marking only the top and bottom step nosings, leaving unmarked the middle one in this case. Note other safety problems with this stairway including camouflaged tread surfaces, confusing markings on the lower level and veiling glare on the floor ahead.

In recent years, stairway safety investigators Cohen and Pauls have collaborated on a handbook chapter focused on visibility issues, marking and warnings for pedestrian dangers; this provides an authoritative treatment of these topics. For example, the dangers of incomplete marking of some nosings of stairs are noted. Exhibit 7 shows a classic example how visually confusing the marking of only top and bottom nosings of a stair can be, illustrating the worst-possible scenario with a three-riser stair with the middle nosing left unmarked, the stair finish being one of the inherently camouflaged stone surfaces and—as if that were not enough—the designers have added an additional confusing marking on the landing. The subject stair is in a prestigious California hotel lobby and provides a damning indictment of the commonly used rule or

convention in California to mark only the top and bottom nosings of stair flights. Further exacerbating the dangers of the stairway is the presence of veiling glare in the background that would further reduce an older person's ability to safely detect the presence and location of all the steps.

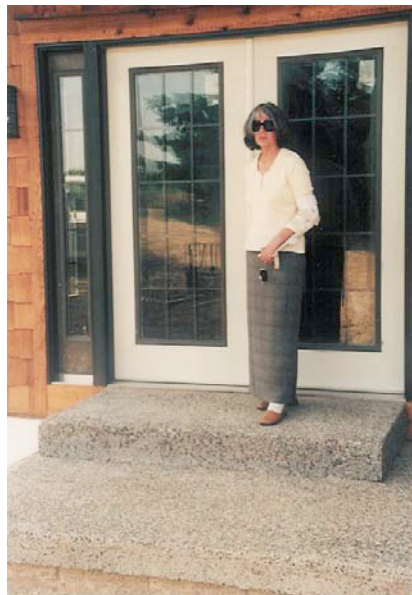
Exhibit 8: This home entrance was the site of a fall by the building owner on her first use of the entrance after the builder, responding to the owner, added the platform but made it too small and difficult to see for a person coming out the doorway.

Exhibit 8 depicts a badly constructed, undersized platform at the entrance to a new home; the woman owner of the home fell on her first use of the entrance after she had insisted the builder add the platform because the original step down at the door was considerably higher than permitted even by the relatively lax code for dwelling construction used in the locality. Given that such platforms, not at the level of the doorway (unlike here), are permitted by codes, such cases pose challenges for the expert serving on behalf of the plaintiff. Careful attention must be paid in such cases to the minimum landing sizes called up by the codes as well as other, non-code issues such as visibility of the landing edges; both were serious problems with the exposed aggregate concrete finish and undersized platform employed here.

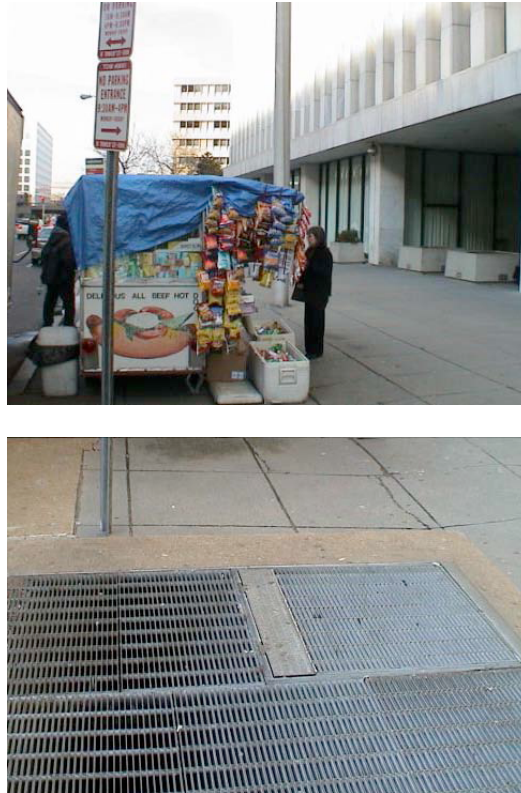
Exhibit 10: This is an example of two of many photographs taken to document the exact location of a misstep and fall as well as the context that had special importance to the person falling. In this case, other documentation showed there were elevation differences here that are visually hidden.

Sidewalk discontinuity cases need the same kind of careful attention to detail that is needed for cases involving stairs. An electronic level as well as laser levels should be employed to establish exact elevations and walking surface slopes. A variety of photos should be used to establish context (with lighting conditions, shadows, etc. similar to those at the time of the fall) as well as the details of the area where the misstep occurred. Exhibit 10 shows a pair of many photographs taken to document a fall site at the junction of a grated area and a concrete sidewalk.
