EMERGING TECHNOLOGIES: Hazard Assessments Find SAME OLD PROBLEMS

By LAURA L. HODSON
and ROBERT E. UHORCHAK

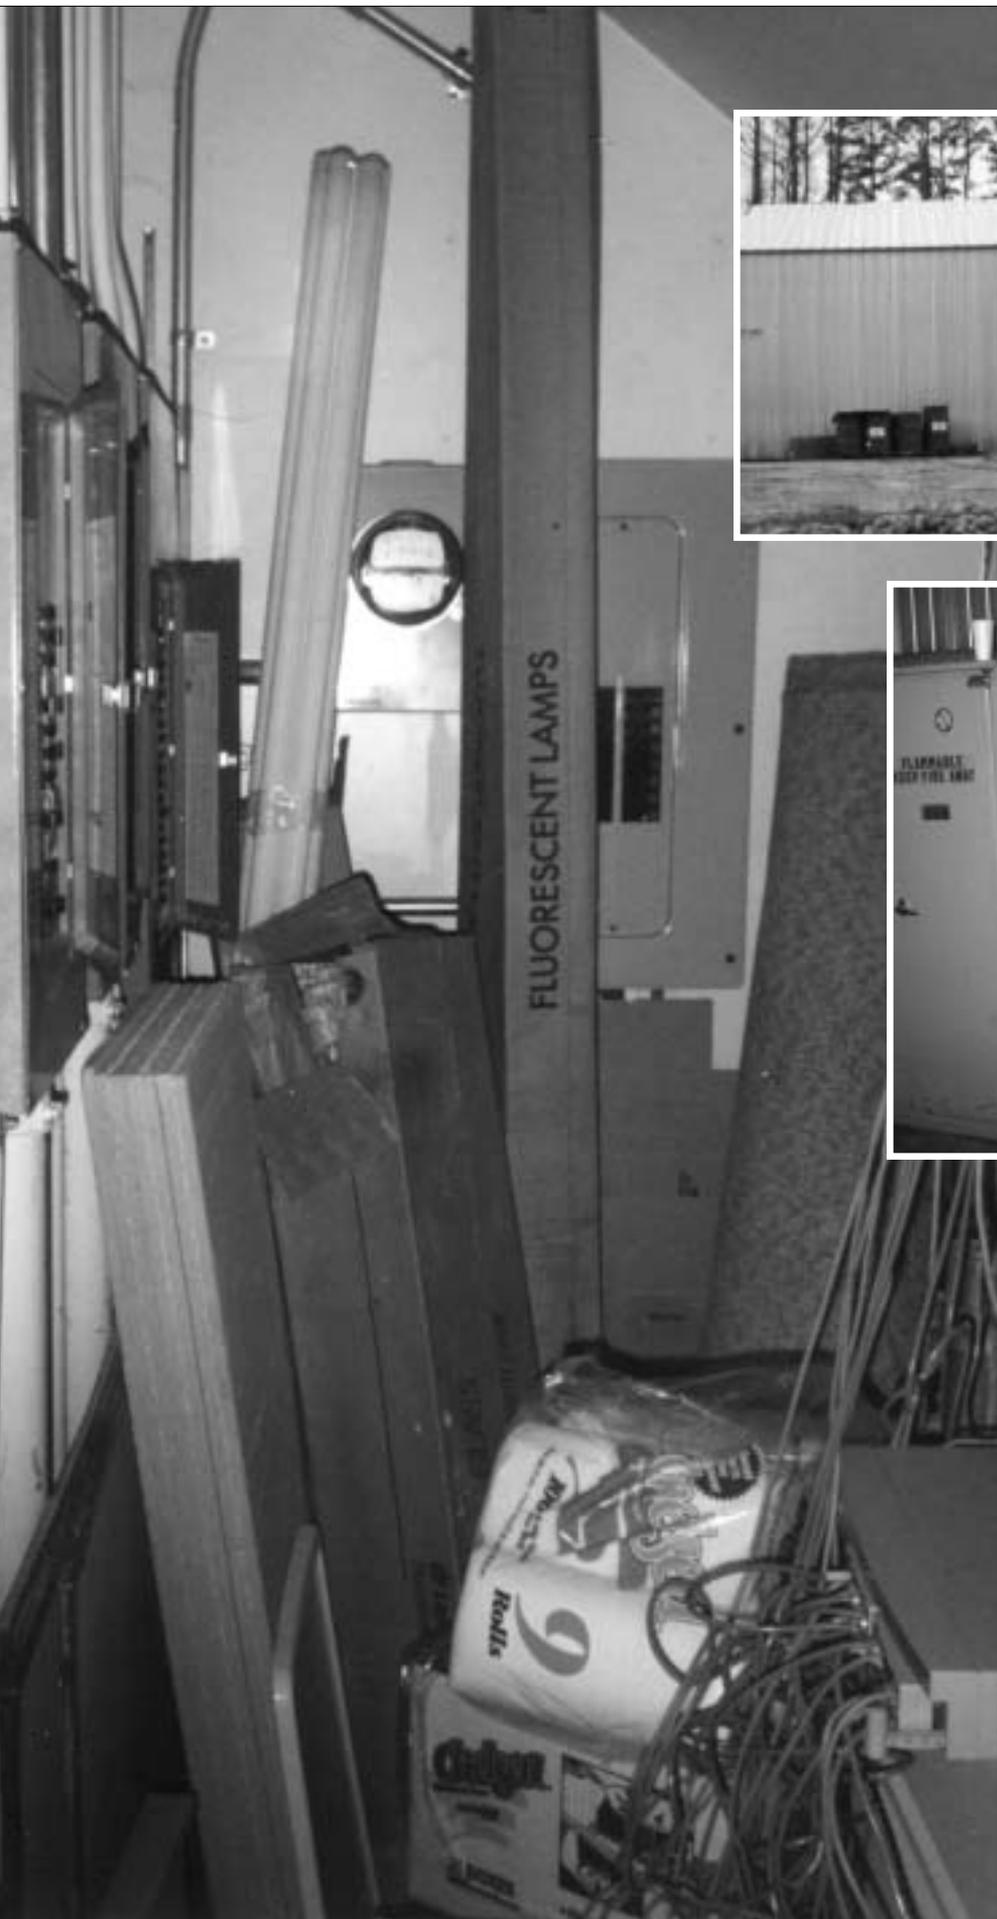
(Left): Electrical safety was universally inadequate. Access to electrical control panels was often obstructed by clutter, and circuit breakers were unlabeled and often had no protective blanks. In many cases, required ground fault circuit interrupters were not in place.

Electrical safety was universally inadequate. Access to electrical control panels was often obstructed by clutter, and circuit breakers were unlabeled and often had no protective blanks. In many cases, required ground fault circuit interrupters were not in place. Extension cords were damaged, improperly taped and used as permanent wiring. In one facility, an extension cord ran through a broken window of one building to another building.

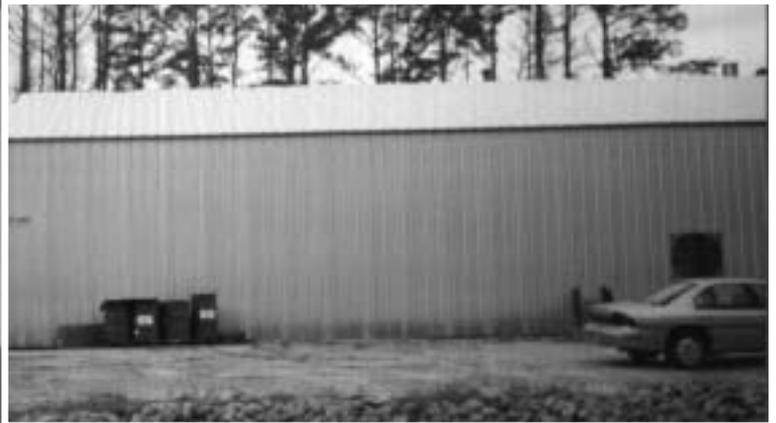
(Top): The assessment found that the facilities often did not have the same degree of concern about materials stored outside as for those stored inside. For example, in this parking lot, no barriers were in place to protect the drums from vehicle traffic.

The assessment also found that the facilities did not have the same degree of concern about materials stored outside as for those stored inside. Some facilities had secondary containment, while others stored 55-gal. drums within easy access of vehicles. None had formally considered hazards from adjacent properties. For example, at one site, a boulder was blocking the nearest fire hydrant; at another, an adjacent property had an uncontained fuel oil tank that could leak fuel onto the site.

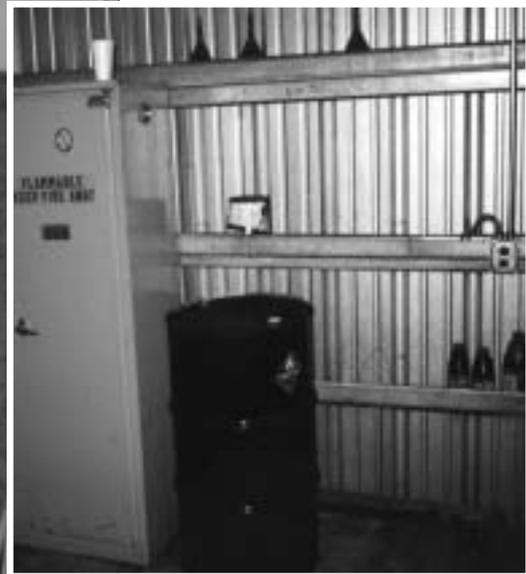
(Above): At one facility, unlabeled liquids were found in used drink bottles around machine shop and mechanical support areas. These presumed flammable liquids were not stored in a flammables cabinet nor was secondary spill containment in place.

Unlabeled liquids were found in used drink bottles around machine shop and mechanical support areas. These presumed flammable liquids were not stored in a flammables cabinet nor was secondary spill containment in place.
