After Queecreek

*A review of projects to prevent coal mine inundations
in West Virginia*

By Gary L. Winn, Robert Rice and James Dean

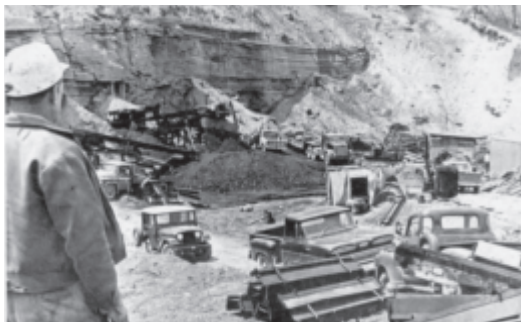
Photo 1: Hominy Falls Recovery Operations. In 1968, Hominy Falls focused national attention on mine inundations.

Quecreek is only the most recent inundation incident in the U.S. mining industry to capture national attention. Another prime example is the Hominy Falls disaster in 1968 at the Saxsewell No. 8 Mine located in Nicholas County, WV. Investigation of this incident found that at 9:40 am on May 6, 1968, a continuous miner broke through into an adjacent abandoned mine. At the time of the incident, 26 men were working in the mine. The resulting inundation of water killed four miners and left 21 trapped—only one worker was able to escape. Of the 21 trapped, 15 miners were rescued five days after the initial inundation; the remaining six miners were rescued 10 days later (USMRA) (Photo 1).

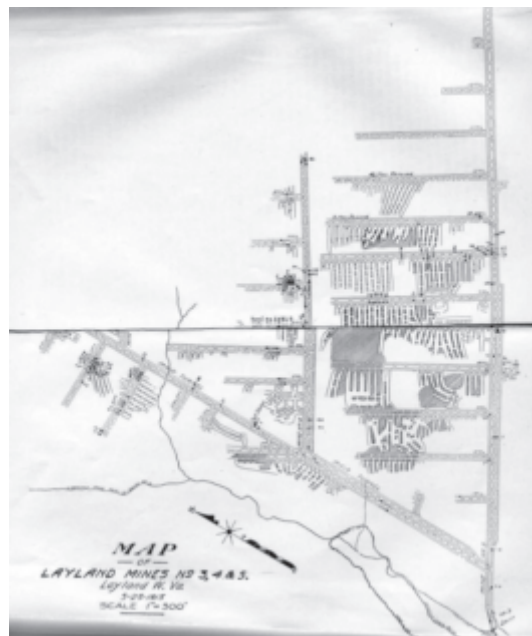
Photo 2: The process of digitizing old mine maps, such as that depicted here, is a long, arduous process being undertaken by the West Virginia Office of Miners' Health, Safety & Training.

in extremely poor condition (Photo 2) or held by deceased miners' family members who may not be cooperative. Other factors can also make this task more difficult. For example, in 2004, the day before the team working to collect and scan mine maps throughout West Virginia was to visit, a coal operator's map warehouse was flooded by rainfall. Of 200 available maps, all but 75 were lost.
