Sludge Gas Leaks

A Novel Approach for Preventing Explosions

By Peter Erndwein

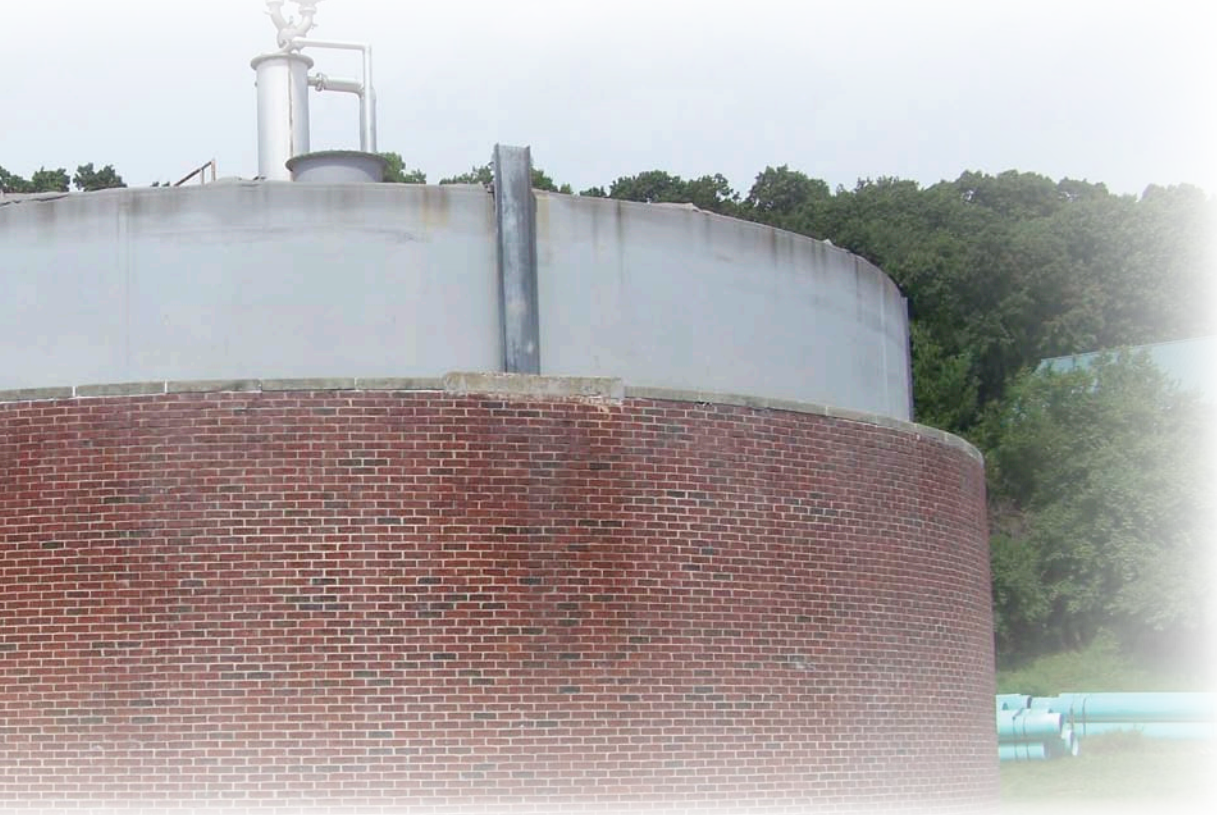
Photo 1: Typical anaerobic sludge digester building.

Sludge gas is managed in several ways depending on the quantity generated and its methane content. The gas may be vented directly to the atmosphere if generated in small quantities (e.g., typically concentrations below 10% lower explosive limit), or the gas may be thermally oxidized via an automatic flare system. Most commonly, however, methane-rich sludge gas is thermally oxidized in an industrial furnace for energy recovery purposes. Less common is thermal oxidation in a gas turbine to produce electric power (Erftverband, 2006). Photo 1 shows a typical anaerobic sludge digester building at a municipal WWTP.

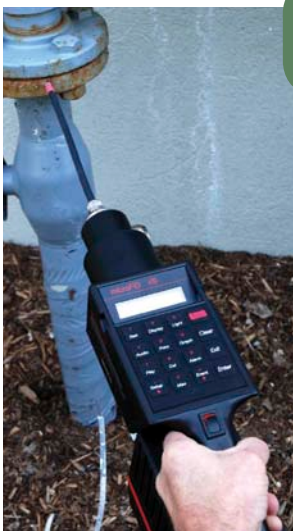
Photo 2: MicroFID portable flame ionization detector (Image Courtesy of Photovac, an INFICON Brand).

and it is commonly employed for EPA Method 21 monitoring. Based on the manufacturer's literature, the instrument has a lower detection limit for methane of 0.5 ppm with a detection range of 0.5 to 50,000 ppm (PerkinElmer Inc., 2000). Photo 2 shows how an FID might be used in a field survey mode. Given the nature of treatment operations and the potential for interference from trace VOCs, an action limit of 1,000 ppm was established as indicating a significant methane leak. This level was approximately an order of magnitude below the lower detection limit of the fixed and handheld explosive gas monitoring equipment available to employees at the WWTP where the explosion occurred. The consulting firm then visited each target WWTP and conducted an FID scan of all accessible methane collection piping and system components.

Flame ionization detectors (FIDs) are portable, direct-reading monitoring instruments capable of detecting a wide variety of volatile organic compounds including methane at low ppm concentrations. The instruments are commonly used in emergency response and environmental remediation operations. The FID is also the instrument of choice when performing fugitive emission monitoring, according to U.S. EPA Method 21 (PerkinElmer Inc., 2000).

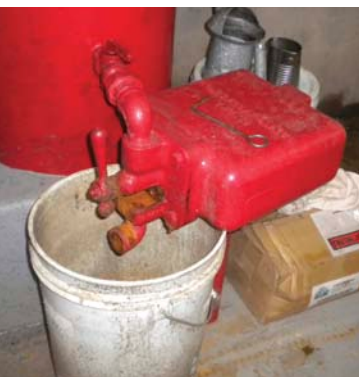
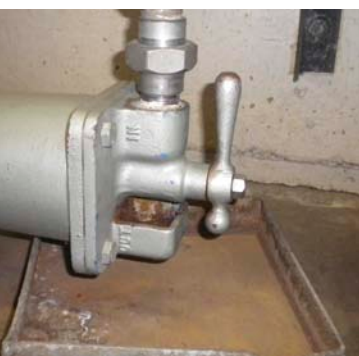
Photos 3 and 4: Typical condensation drip traps.

Of considerable interest was the observation that four of the five facilities actively collecting methane had significant leaks associated with the condensate drip trap process component. Because water vapor is a normal component of sludge gas production, drip traps are standard process components designed to remove potentially corrosive moisture from piping systems (ASME, 2001). Drip traps allow the piping to be periodically drained while preventing sludge gas from escaping. Pennsylvania DEP's (1997) permitting guidance directs permittees to install drip traps at low points in the process piping where moisture tends to accumulate. Photos 3 and 4 show examples of typical condensation drip traps encountered during the study.

This unexpected finding suggests that the drip trap seals may degrade over time and, consequently, should be targeted for periodic preventive maintenance checks. A web search did not indicate that this concern has been previously described in

the literature. This finding also suggests that the area near a drip trap is a good location for a fixed gas monitoring system sensor. The sensor could provide an early warning of seal degradation. Subsequent to this discovery, risk control staff performed an Internet search to locate manufacturer guidance for drip trap inspection and maintenance. Most manufacturer literature found did not specify maintenance and testing intervals or procedures. One manufacturer provided a comprehensive installation, operation and maintenance guide for its line of manual drip traps. This guide stated, "It is important to regularly inspect and clean drip traps, especially their seating surfaces." No inspection interval was specified, however. Detailed maintenance procedures were then described (Groth Corp., 2003).
