# SLIDE GUARD EFFECTIVENESS on Steep-Sloped Roofs

By Thomas G. Bobick, E.A. McKenzie Jr. and John R. Powers Jr.

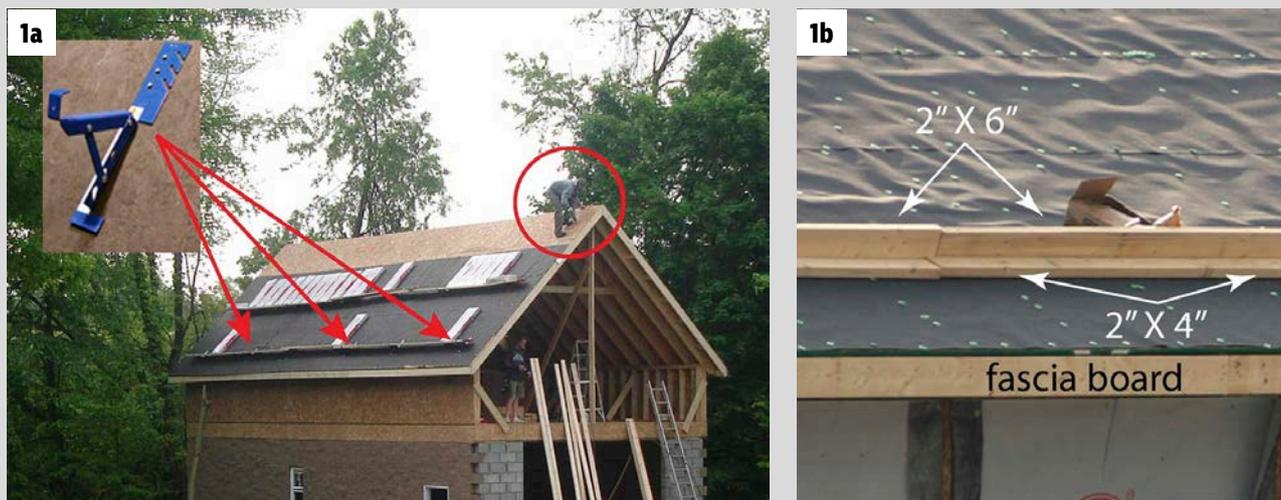
## FIGURE 1 TWO EXAMPLES OF BASIC SLIDE PROTECTION

Figure 1a (left): Typical roof construction using roofing jacks (inset, upper left) for placement of supplies and for fall protection. An unrestrained worker is shown (in the circle) at the roof peak. Figure 1b (right): Typical roof construction, using two-by-six and two-by-four lumber for a fall protection slide guard.

On-site observations by the project team indicated that some contractors use a commercially available roofing bracket, also referred to as a “roof jack,” to create a flat walking-working surface at the downslope edge (eave) of the roof for working purposes and for basic slide protection (Figure 1a, p. 30). Other contractors use a combination of two-by-six boards supported by two-by-four boards (Figure 1b, p. 30) to serve as a slide guard or to provide something to brace against while working on the roof. The commercial roofing brackets or fabricated wood slide guards are secured to the roof by nailing into the roof trusses (or rafters) to secure the lumber or metal brackets. The slide guard is repositioned as roofing work progresses up the roof, or additional slide guards are added at regular intervals upward, toward the roof peak, also shown in Figure 1a.

The objective of this pilot project was to evaluate whether a slide guard setup (Figure 1b, p. 30) will prevent a human-sized mannequin from sliding over the roof edge. The mannequin served as a surrogate for an unconscious worker sliding downslope on a small sample of typical building materials used in steep-sloped residential construction.

The test apparatus was a human-sized mannequin with a stature of 74 in. and a weight of 234 lb. This represents the 92nd percentile for height and the 91st percentile for weight of the adult male population (age 18 to 65) of the U.S. (Harrison et al., 2002). This national database would correspond to the typical U.S. construction workforce but is not meant to correspond to any specific trade group, such as electrician, plumber or roofer. For this evaluation, the mannequin served as a surrogate for an unconscious worker: someone who passed out from heat stress or an illness or who was knocked unconscious from an impact to the head. Regardless of the cause, the unconscious worker would drop and start sliding without offering any resistance to sliding downslope. The mannequin was used with all eight roofing materials and the two different roof slopes. At the eave (the drip edge of the test roof), a two-by-six and two-by-four slide guard system was installed, which is shown in Figure 1b.

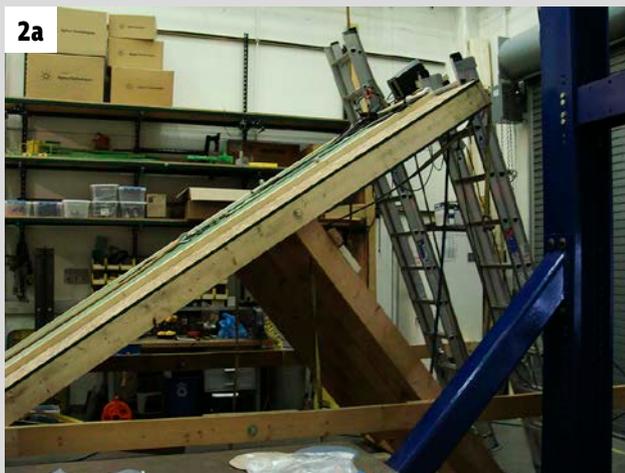
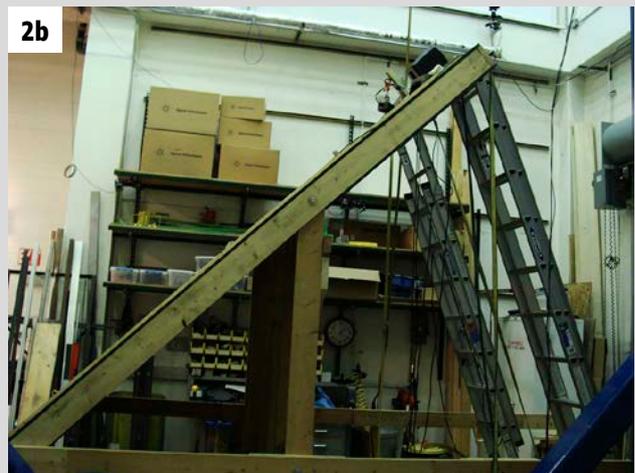
## FIGURE 2 TEST ROOF CONFIGURATIONS

Figure 2b (left): Test roof configuration for the 8 in 12 (34°) slope. Figure 2b (right): Test roof configuration for the 12 in 12 (45°) slope.

The wood frame roof mock-up was constructed in the test lab using typical construction materials: two-by-six and two-by-ten lumber for the framework, and for the roof surface OSB material for the sheathing. The narrow roof portion was 8 ft wide and 15 ft in length. Figure 2 shows the two configurations tested. Both configurations [8 in 12 (34°) and 12 in 12 (45°)] were used for the testing. The base of the roof structure was fabricated using two-by-ten lumber and was positioned directly on the lab floor.

Testing began with the test roof set to the lower of the two slopes, 34° (Figure 2a) using the mannequin, which was positioned at the top of the test roof in a standing orientation. Three sheathing materials and five underlayment materials were evaluated at the lower slope (34°), then the same eight materials were evaluated at the steeper slope (45°). One slide was tested for each of the 16 conditions. A new slide guard system was constructed and fastened to the test roof for each slide. New 16-penny nails (3.5-in. length) were used to fasten the lumber together and to fasten the slide guard to the roof. Only 16-penny nails were used in the testing since they are the nail type most commonly used by wood framers in the north-central West Virginia area. Using longer nails would not have been appropriate because the research team wanted to approximate the residential construction activities in West Virginia.

Because of time restrictions, only one test was conducted for each material and slope combination. At the conclusion of the pilot testing, the roof structure (described in the “Test Roof” section and shown in Figure 2, p. 31) had to be moved so that the next test setup could be constructed in the lab. The test roof was disassembled and set aside. Eventually, the lumber was used in other NIOSH research projects. Thus, no further opportunity exists for the researchers to conduct additional follow-up measurements for different variables such as a wet condition, different sized nails and different sized lumber for the slide guard. These are all excellent variables to be investigated by other researchers.
