AT-A-GLANCE

A Proven Technique to Mismatches & Cross

By Jean Ndana

EXCESS LABELING to Minimize Chemical Cross Contaminations

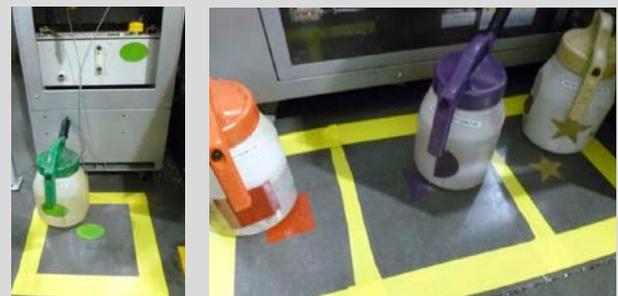
FIGURE 4 PROPER STORAGE & LABELING

Labeled portable containers stored at their designated area.

Step 7 establishes a secondary container storage area to create dedicated storage areas for portable containers. A dedicated space prevents containers from being stored in many locations, reduces the chance of a mismatch and helps machine operators easily find a container to retrieve their oil. Figure 4 shows portable containers stored at their designated areas.

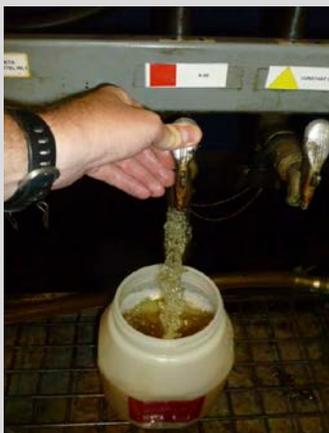
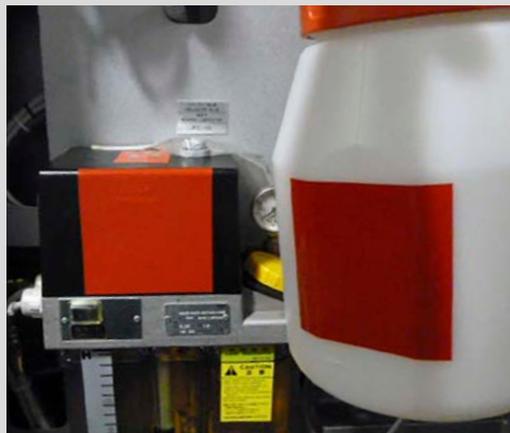
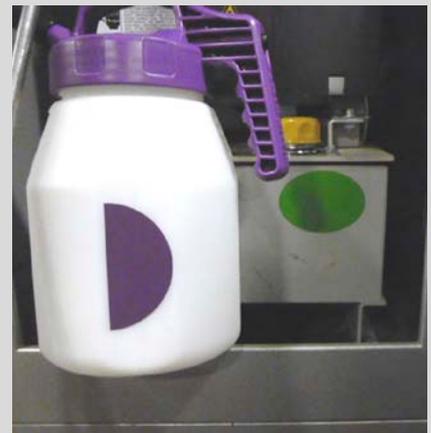
Photos 5, 6 and 7 are from the match game. Photo 5 (left) shows matching colors and shapes from the source to the portable container. Photo 6 (center) shows matching colors and shapes from the portable container to the machine. Photo 7 (right) shows mismatching oils.

Step 8 is training, which rolls out the plan throughout the plant and educates workers on the system. A match game was implemented to help workers understand the system. The game involved helping workers understand the color-coding system by matching up shapes to confirm that they have the correct oil from the source, that they are using the right container, and that the oil going into the machine is correct to avoid mismatches and cross contamination. Photos 5, 6 and 7 (p. 44) were used in the match game to educate workers. The plant established an annual refresher training program to continually remind workers of the labeling system in place.
