# PEDESTRIAN

## Hidden Hazards in Common Landscapes

# WALKWAYS

## Risks Related to Edging Practices

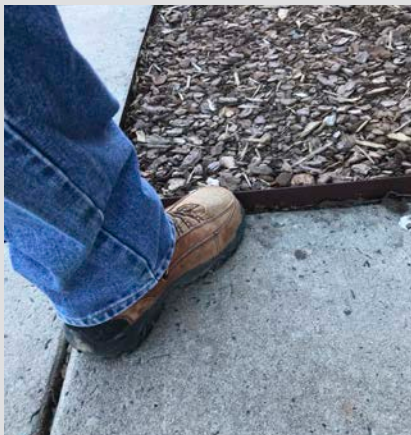
**Photo 1 (left):** Edging not flush with the walkway that allegedly caused a fall. **Photo 2 (below):** A sidewalk with major uplift from tree roots.

Photo 1 shows edging alleged to have caused a person's fall at the entrance to a nationwide chain restaurant. The sidewalk was designed with a 90° angle for adjoining sidewalk sections and did not include a curve at the junction of the two sidewalk sections, which created a desire path. However, the edging did make a 90° turn to follow the

sidewalk (K. Waegerle, personal communication, July 27, 2021). All these ambulatory design issues are discussed in sections that follow.

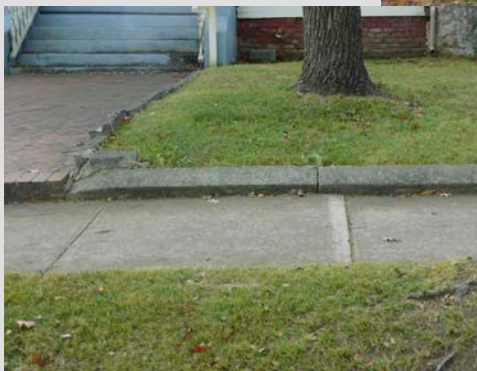
**Photo 3 (above):** Example of a beveled sidewalk because of uplift. **Photo 4 (right):** Campus desire path.

The Americans with Disabilities Act (ADA) Standards for Accessible Design specify that the beveled slope of edge displacements between 0.25 in. and 0.5 in. must have a minimum slope of 1:2 (U.S. Department of Justice, 2010). Some states such as North Carolina adhere to International Code Council (ICC) codes including A117.1 (2017). Chapter 11 of the North Carolina Building Code (2018) states that “buildings and facilities should be designed and constructed to be accessible in accordance with this code and ICC A117.1.” ICC A117.1 (2017) contains a similar provision to the ADA standard, as it states that the maximum vertical level change shall be 0.25 in. and that the beveled slope of edge displacements between 0.25 in. and 0.5 in. should be a minimum slope of 1:2. When vertical displacement has occurred, such as is shown in Photos 2 and 3, it often requires repouring or repaving that section of the walkway.

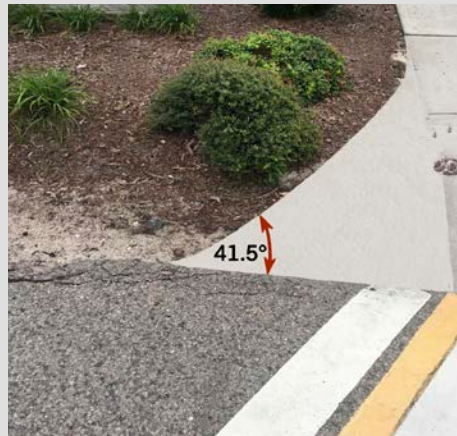
(Left to right) Photo 5: Concrete addition to eliminate 90° junction. Photo 6: Bent landscape edging due to high pedestrian traffic along desire line.

Photo 5 shows an example of a desire path with no shorter route as well as a markup of where a flare has been added to the sidewalk so that pedestrians are not walking on uneven ground or have debris in their desire path.
