# Rollover Collisions

*Injuries related to automotive side glass*

By Stephen A. Batzer

**Abstract:** The injury mechanisms associated with tempered and laminated side glazing in automobile rollover collisions are enumerated and analyzed. The effects of impact, containment loss, entrapment, laceration and eye injury are discussed.

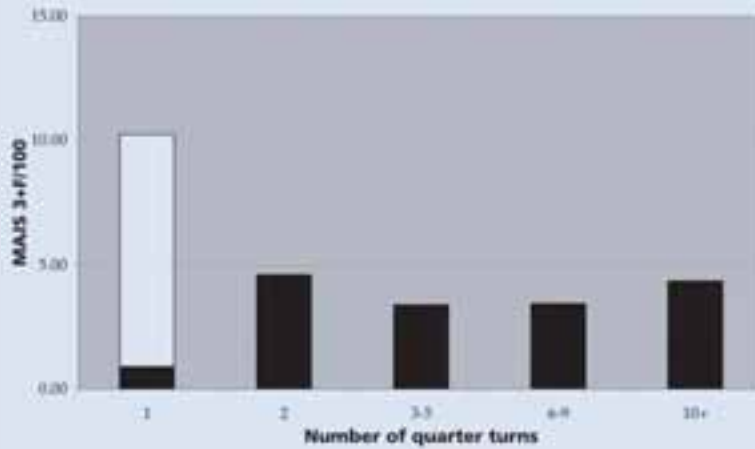
**Figure 1**

## Injury Rate: Front Seat Occupants

*Note.* Injury rate of unbelted nonejected front seat age 12+ occupants with MAIS 3+F injuries in single vehicle rollovers by number of quarter-turns. Dark = pure roll-related injury; light = injury due to impact with fixed objects or vehicles. From "Crash Attributes that Influence the Severity of Rollover Crashes," by K. Digges and A.M. Eigen, 2003, Proceedings of the ESV Conference, paper 231.

Digges and Eigen (2003) showed that even in multiple-roll rollovers, the rate of injury, even for unrestrained occupants is low (Figure 1, p. 36). Within the population of one-quarter-roll collisions (vehicle rotates a net 90° about its roll axis), a substantial 94% of the severely injured occupants received their injuries either from impact with another vehicle initiating the rollover or from impacts with fixed objects (e.g., trees, poles) either before or during the rollover. By removing these two conditions, the injury rate for quarter-turn collisions is less than 1 per 100 exposed (Figure 1). Most vehicles that roll do so about the principle travel axis of the vehicle. These are called barrel rolls. A small number of occupants involved in rollovers—3.6%—are in "end-over" rolls about the pitch axis and generally suffer a greater level of injury.

mately 4% of unbelted occupants incur severe injury or death in rollovers when completely contained; this percentage declines to about 2% for belted occupants. This is in good agreement with Figure 1.

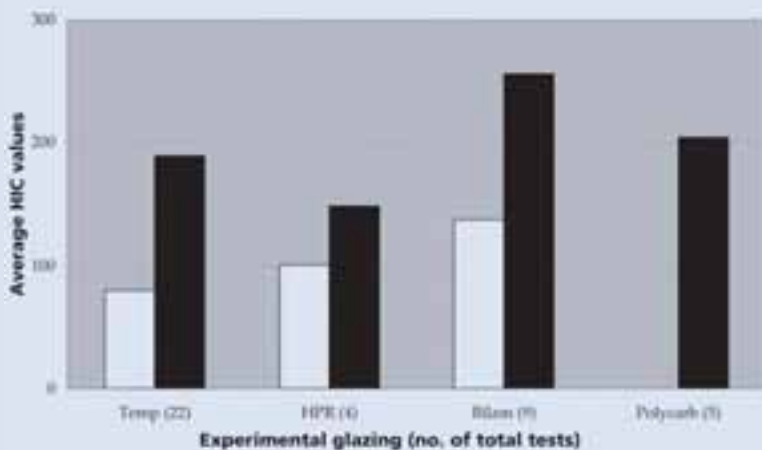
**Figure 3**

## Average Center & Corner Impact HIC Values

*Note.* Average of center and corner impact HIC values for 23.6 kph (15 mph) strikes. Light = broken; dark = unbroken. From Ejection Mitigation Using Advanced Glazing: Status Report II, by NHTSA Advanced Glazing Research Team, 1999.

The results of the free motion headform tests indicated that head or brain injury is unlikely with any side glazing formulation considered. A combination of hits to the geometric center of the glazing and the upper rear corner were used; their averages are shown in Figure 3. (Note: For this and other NHTSA graphs, the number of individual tests per glazing type is included in parentheses.)

As expected, unbroken sidelights produce more of a direct injury mechanism than do broken sidelights that fail to completely retain the headform. Notice that the polycarbonate glazing (currently not allowed within the U.S. as a material for windows requisite for driver visibility) never failed to retain the headform.

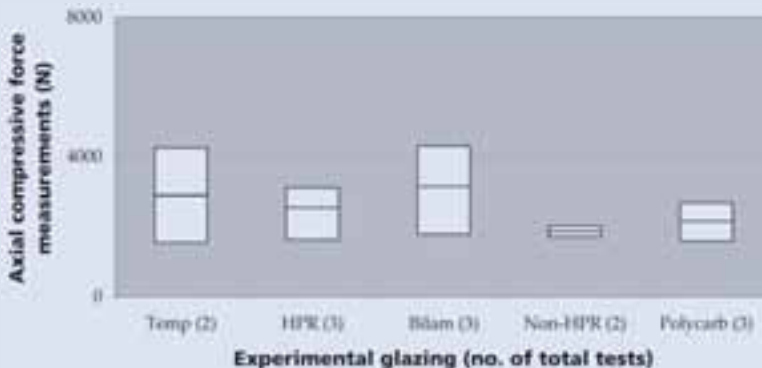
**Figure 4**

## Axial Compressive Force Measurements

*Note.* Axial compressive force measurements for 23.6 kph (15 mph) impacts minimum/average/maximum values. From Ejection Mitigation Using Advanced Glazing: Status Report II, by NHTSA Advanced Glazing Research Team, 1999.

The tempered and bilaminate glazings gave the highest axial compression forces, followed by HPR, polycarbonate and non-HPR. The moments about the occipital condyles were highest for HPR, followed by the bilaminate, polycarbonate, non-HPR and tempered glazing. The neck values were highest when the head strike preceded that of the shoulder. The highest lateral neck shear force was incurred with bilaminate and polycarbonate glazing. Several research and companion studies have shown that the potential for neck injury due to impact into laminated side glazing is low

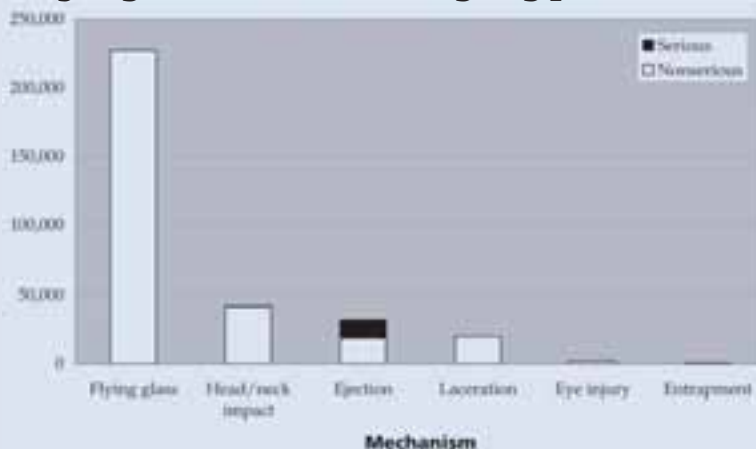
**Figure 7**

## Estimates of Side-Glazing-Related Injury Occurrence by Type

*Note.* 1999 estimates of side-glazing-related injury occurrence by type side glazing injury statistics—towaway collisions, passenger vehicles. From Ejection Mitigation Using Advanced Glazing: Status Report II, by NHTSA Advanced Glazing Research Team, 1999.

Figure 7 illustrates side-glazing injury rates for towaway accidents based on various sources. In 1999, nearly 227,500 injuries were due to flying tempered glass fragments, making this the dominant

DOT, 2006). The estimate of true instances of glazing-caused entrapment (not injury) performed for this article (Figure 7) is 600, based on the number of towaway accidents recorded for 1999 and the incidence ratio cited previously (DOT, 2006; Campbell & Bopens, 1964); this does not necessarily indicate injury. The statistics show that 99.5% of nonejection-related side glazing injuries are not serious.
